AFPEA REPORT NO. 86-R-04 AFPEA PROJECT NO. 84-P-101 AD NO.

TEST AND EVALUATION OF CLEATED CORRUGATED PLASTIC CONTAINERS

HQ AFLC/DSTZ
AIR FORCE PACKAGING EVALUATION AGENC/
Wright-Patterson AFB OH 45433-5999

May 1986

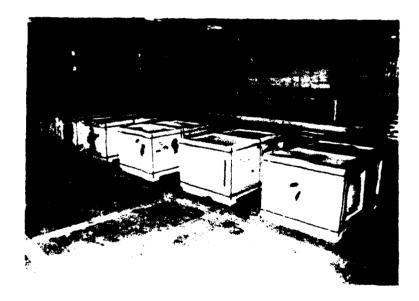
Service testing of the large containers (44"x31"x24") shown in Figure 5 began on 22 Apr 85 with the shipment of six each large cleated plastic containers consisting of one pair of containers each carrying a type 3 contents load of 300 pounds, a second pair each carrying 400 pounds and the third pair each carrying 500 pounds. Contents were similar to that described for the small containers. The service test for the large containers was terminated in December 1985 when the containers had completed 10 round trips. In general, minor maintenance and repairs on the containers were sometimes necessary in instances involving an occasional loosened cleat, loosened, broken or missing banding,

a minor split (no hole) in the plastic panel of 2 different boxes, and a missing skid in two instances.

figure 5, Large (42"x29"x30") containers used in the Field Service Test. Each container of 3 pairs carried 300, 400, and 500 pound Type 3 loads for 10 air-truck round trips and was still reusable.
